**CASE STUDY:** *Organic Water Block helps operator avoid plugging well with minimum cost.*

## Organic Water Block in Cement

**Organic Water Block used in remedial cement kept operator from having to plug well and allowed proper placement of cement behind pipe**

Location: Oklahoma

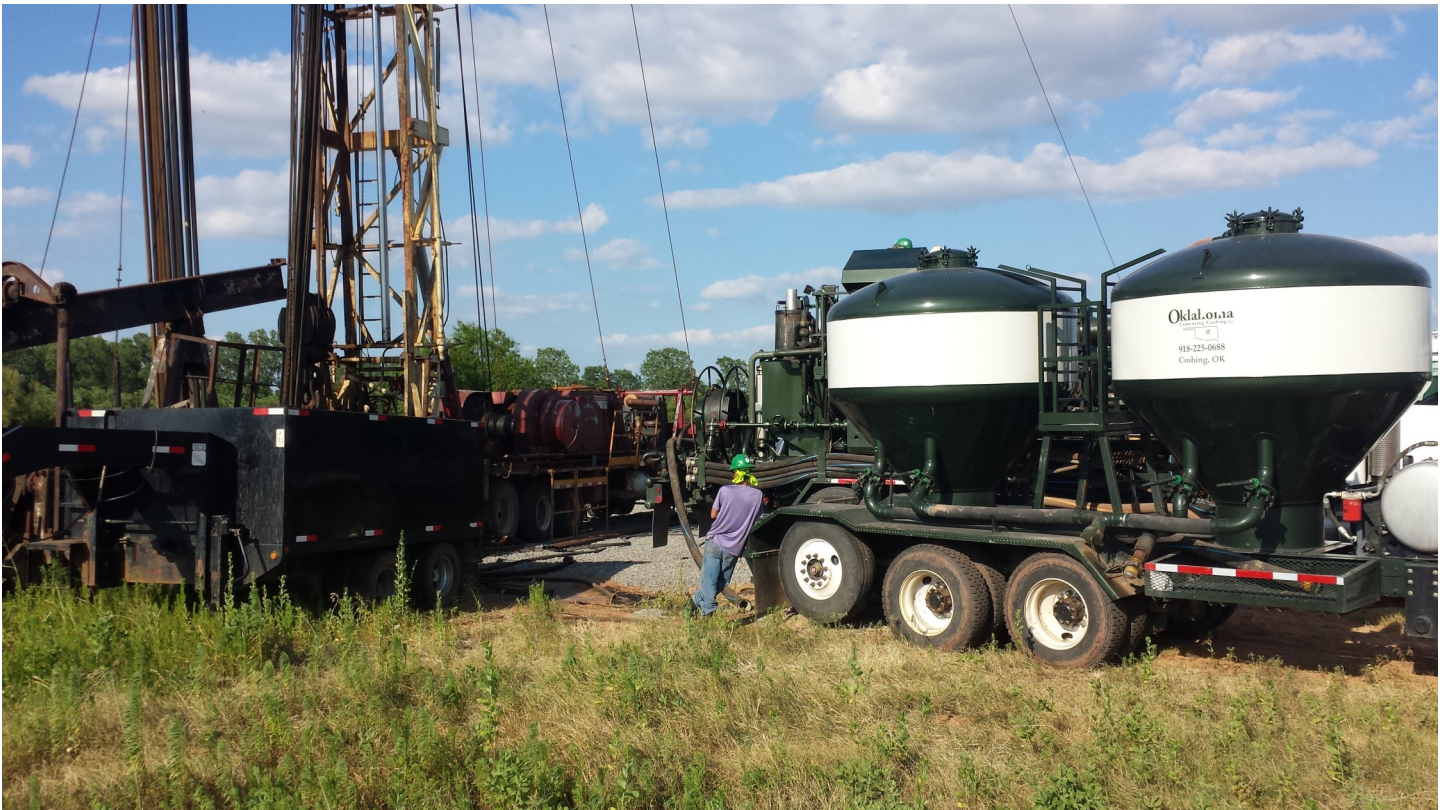
After setting the squeeze packer, and testing the back side, KCL water was pumped into the casing leak to establish the pump pressure and rate. It was determined that 1.75 bpm could be pumped into the hole at 650 psi. After establishing the rate and pressure, 100 sx cement with 2% CaCl and 33 pounds of Organic Water Block (OWB) were mixed. The slurry was then pumped at a rate of 1.5 bpm. After pumping approximately 60 sacks of the slurry into the casing leak, pressure began to climb and flush pump in was initiated being very careful not to over flush the tubing and casing volumes. After waiting on the cement to stop moving, pressure of 750 psi was applied to test the potential movement of the cement. Once determined the cement was setting and not moving, the tubing and packer were flushed and the packer was tripped out of the hole while maintaining hole fluid volume. The well was shut in for 36 hours with 300 psi applied at the surface. Approximately 70 feet of cement was drilled out of the casing before entering into the bad spot where the casing leak was. After drilling through the cement plug past the bad spot, no other influx of water was encountered and mechanical integrity was established with pressure on the entire long string. Picture of the job below.
